Report to Town of Primrose and Primrose Gun and Conservation Club

Topic: Lead levels in soil within club sporting clay area

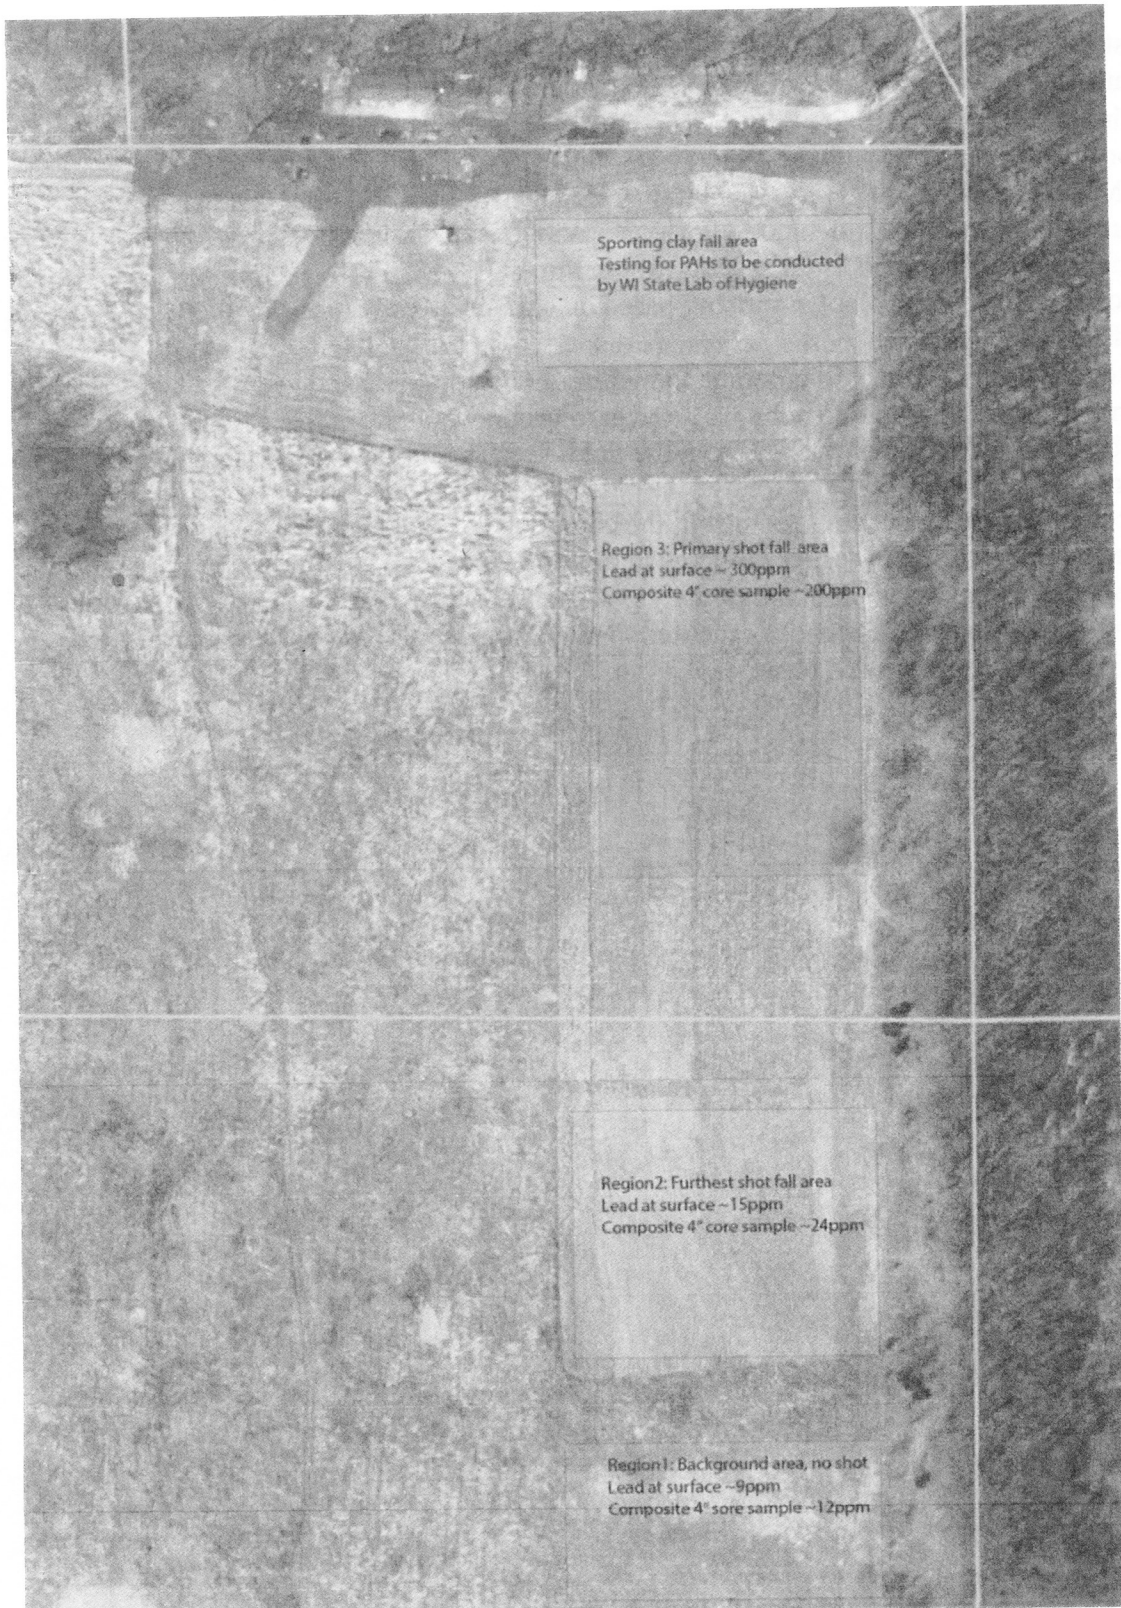
Sporting clay fall area
Testing for PAHs to be conducted
by WI State Lab of Hygiene

Region 3: Primary shot fall area
Lead at surface ~ 300ppm
Composite 4" core sample ~200ppm

Region 2: Furthest shot fall area
Lead at surface ~15ppm
Composite 4" core sample ~24ppm

Region 1: Background area, no shot
Lead at surface ~9ppm
Composite 4" core sample ~12ppm

The composite samples were collected from three regions within the shooting area. Region 1 is beyond the further range that shot is expected to fall and can be considered to give background soil elemental values. Region 2 is from the furthest range that shot can be expected to fall to where shot is estimated to likely fall (per club member estimates). Region 3 is the area where shot is expected to fall most heavily. Surface XRF Pb sample analysis confirmed estimates of shot fall density. One additional composite sample was collected within the area closest to the gun stands for analysis for PAH compounds. A map of the sample locations is attached.

Sample analysis showed that the soil lead background values for the area are approximately 12ppm (mg/kg) (Region 1). Region 2 showed a slight increase to 24ppm. Region 3 soil averaged 198ppm. The region 3 surface sample were generally higher than the composite. This is likely due to dilution from soil with lower lead concentrations from below the surface being mixed with higher Pb surface soil. The variation (79-307ppm) seen in the samples analyzed from Region 3 are typical of that expected with discrete sample analysis as soil is a highly heterogeneous matrix. Composite sampling helps to smooth out the variation and give more
